Manhole Inspection Summary

Manhole # S37EE_053MH

Insp Date: **3/22/07 9:28 AM**

Location Address: **1200 BRENTWOOD AVE**

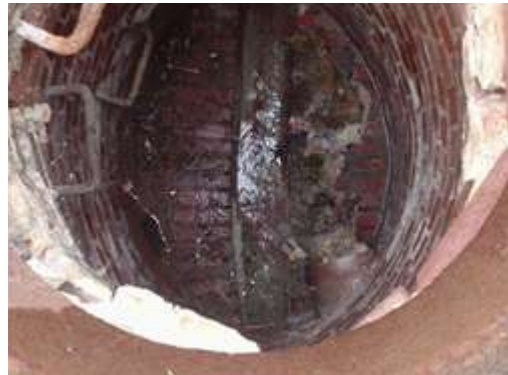
Top View

Corroded steps. Bench and Channel debris.

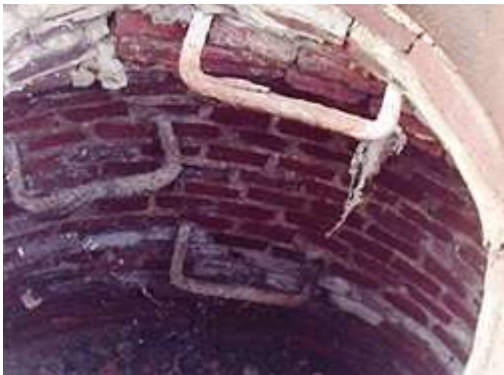
Defect

Barrel infiltration.

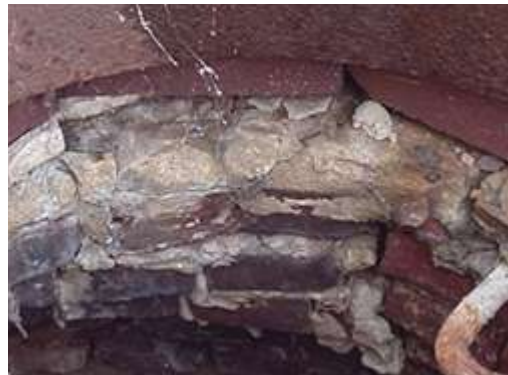
Defect

Adjustment deterioration, loose brick and infiltration. Corbel deterioration and infiltration - other side.

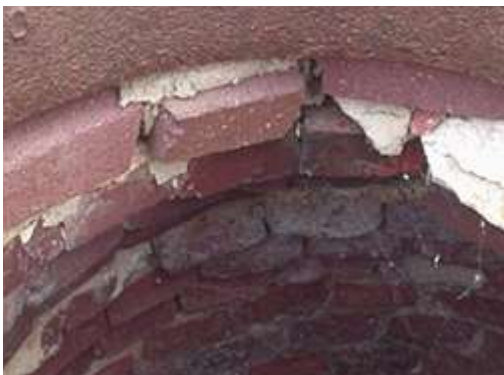
Defect

Adjustment deterioration, loose brick and infiltration. Corbel deterioration and infiltration.

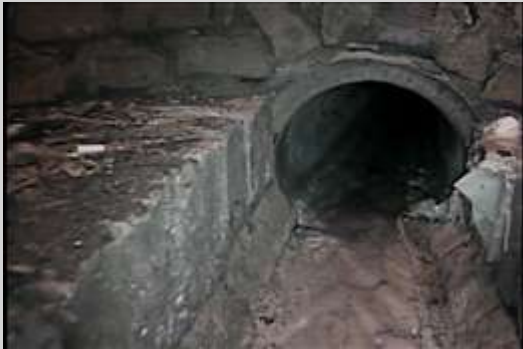
8 in. Circular Gravity Sewer Pipe Out @ 12 O'Clock

Invert Depth: **6.64** (ft.) Flow Characteristics: **Slow**

Deposits: ☐ None ☒ **Mud** ☐ Sludge ☒ **Debris** ☒ **Grease**

Silt Depth: **0** (in.) Deposits Extent: **Light**

Infiltration: **Evidence** Pipe Seal Cond: **Unknown**

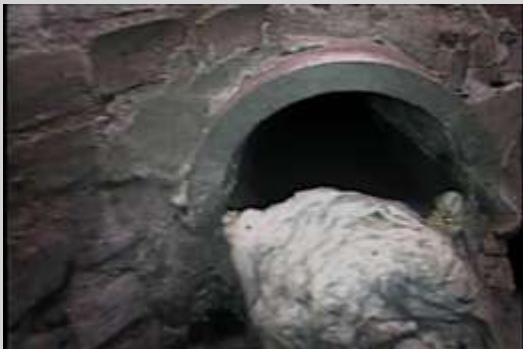
6 in. Circular Gravity Sewer Pipe In @ 4 O'Clock

Invert Depth: **5.85** (ft.) Flow Characteristics: **Slow**

Deposits: ☐ None ☐ **Mud** ☐ Sludge ☒ **Debris** ☐ **Grease**

Silt Depth: **2** (in.) Deposits Extent: **Heavy**

Infiltration: **None** Pipe Seal Cond: **Unknown**

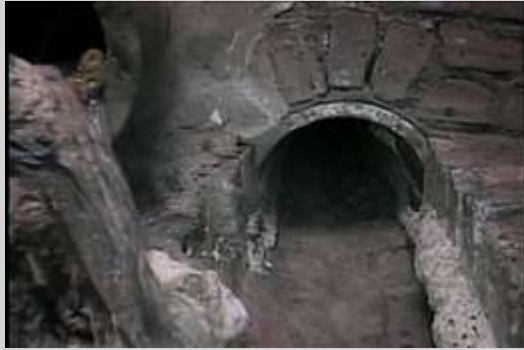
Pipe In @ 5 O'Clock

Invert Depth: **5.65** (ft.) Flow Characteristics: **Slow**

Deposits: ☐ None ☒ **Mud** ☐ Sludge ☐ Debris ☒ **Grease**

Silt Depth: **1** (in.)

Deposits Extent: **Light**

Infiltration: **Evidence**
